Use Attainability Analysis

WBID 2389 Carney Creek

Submitted by
SES, Inc.

Date Received: June 4, 2007

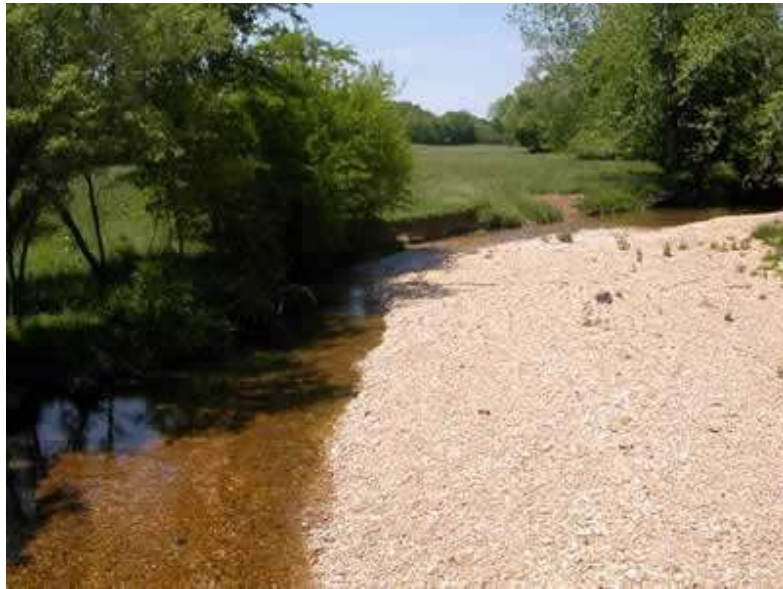
Site# 1 Photo ID# 87, Upstream

WBID # 2389 **Site #** 1
Mark # 44 **Dissolved Oxygen (ppm)** 8.4
Upstream Views Physical Dimensions: Is there any water present at this view? yes

% of Channel Feature				
Riffle	19				
Run	45				
Pool	36

% Cobble	% Gravel	% Sand	% Silt
50	50	0	0
% Mud/Clay	% Bedrock		
0	0

No floating algae. Vegetation on banks, but not in water. Algae on rocks.

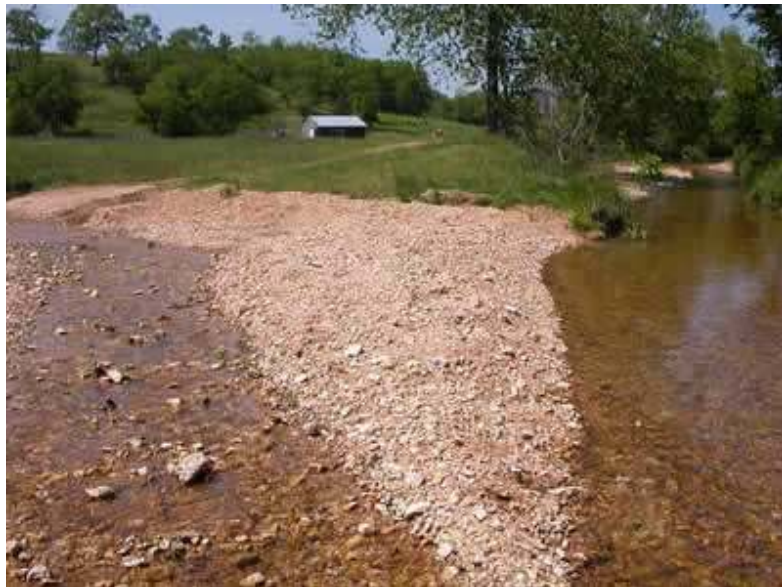
Site# 2 Photo ID# 88, Upstream

WBID # 2389 **Site #** 2
Mark # 45 **Dissolved Oxygen (ppm)** 9.4
Upstream Views Physical Dimensions: Is there any water present at this view? yes

% of Channel Feature				
Riffle	30				
Run	48				
Pool	22

% Cobble	% Gravel	% Sand	% Silt
40	60	0	0
% Mud/Clay	% Bedrock		
0	0

No floating algae. Vegetation along banks. Algae on rocks (little).

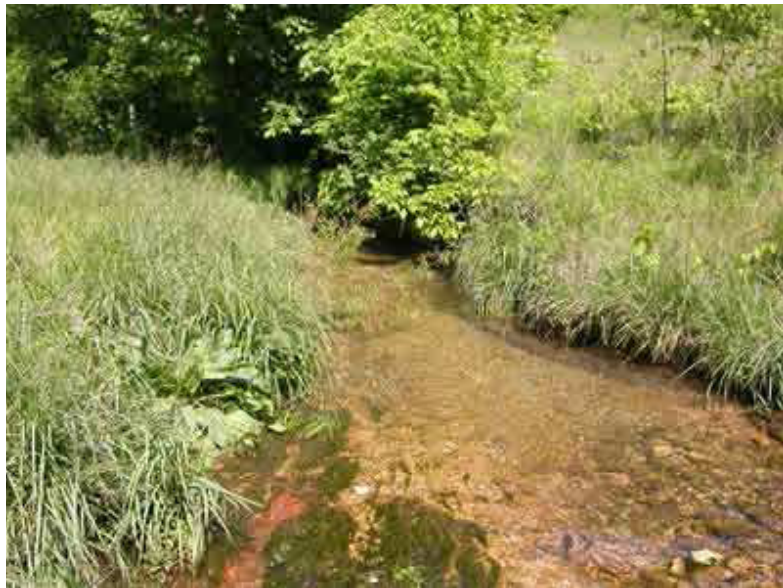
Site# 3 Photo ID# 90, Upstream

WBID # 2389 **Site #** 3
Mark # 46 **Dissolved Oxygen (ppm)** 10.3
Upstream Views Physical Dimensions: Is there any water present at this view? yes
 If so, is there an obvious current? yes

% of Channel Feature				
Riffle	9				
Run	46				
Pool	45

% Cobble	% Gravel	% Sand	% Silt
50	50	0	0
% Mud/Clay	% Bedrock		
0	0

Vegetation along bank. Little algae on rocks. No floating algae. Some filamentous algae in shallow riffles. Wild mint fills the air and grows along bank.
